EVALUATION OF 1978 REHABILITATION SITES AND EROSION CONTROL TECHNIQUES

REDWOOD NATIONAL PARK WATERSHED REHABILITATION

TECHNICAL REPORT
APRIL 1980

MARY ANN MADEJ,
HARVEY KELSEY, AND
WILLIAM WEAVER

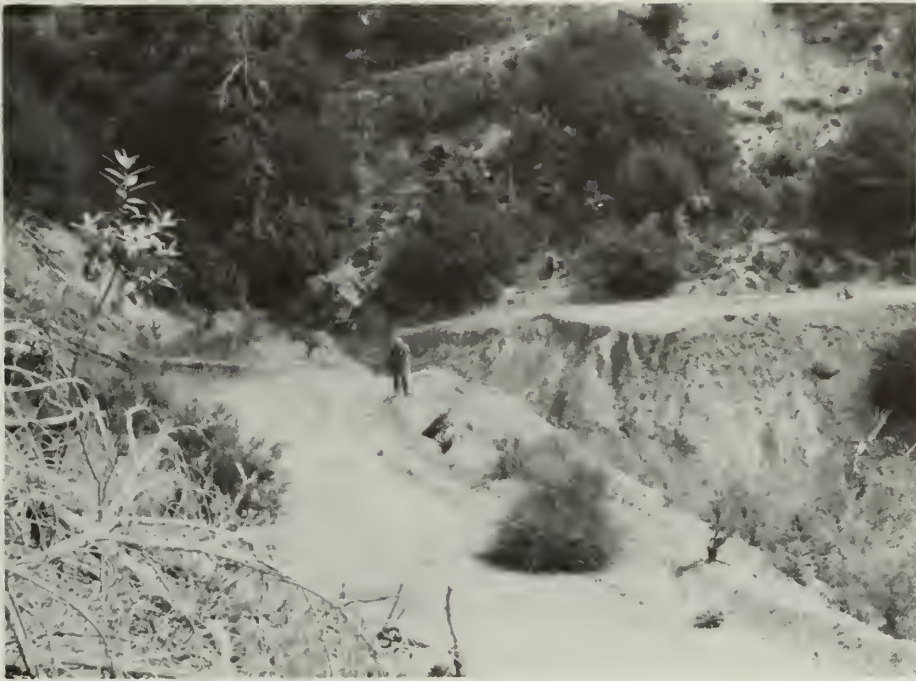
Figure 8: PP5a 8/22/78
Before photograph of former culvert in Drainage 6. Culvert became plugged with debris and winter flows washed out about 800 cubic yards of road fill into the stream channel.

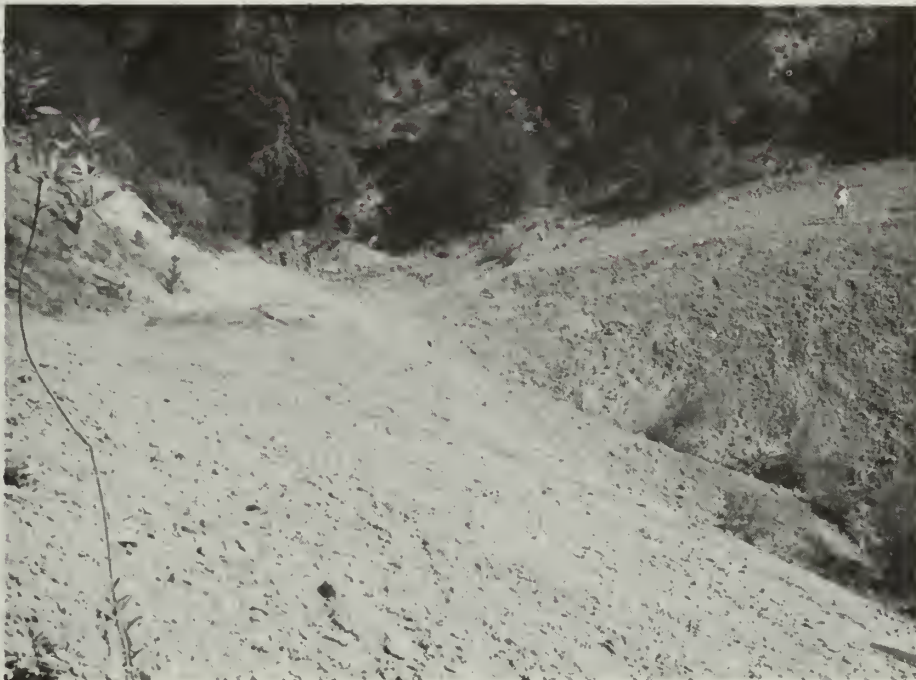
Figure 9: PP5a 10/9/78
After photograph of Drainage 6. Dragline crane pulled back vertical banks to a more stable configuration, and a cat tractor outsloped the fill material removed by the crane.

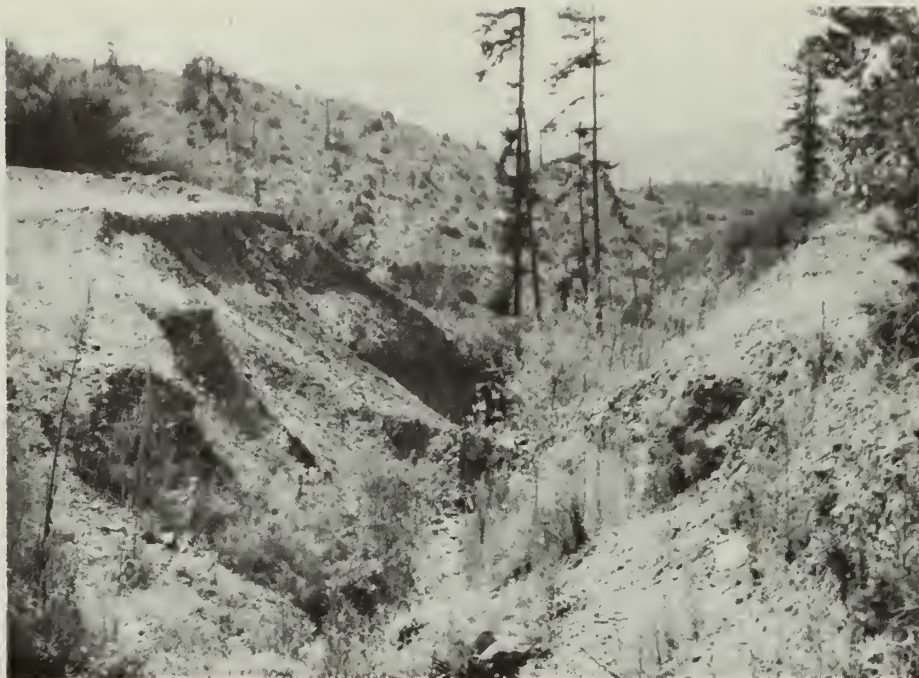
Figure 10: PP7 8/22/78
Before photograph of culvert washout in
Drainage 6, close-up view looking downstream.
Note person in channel for scale.

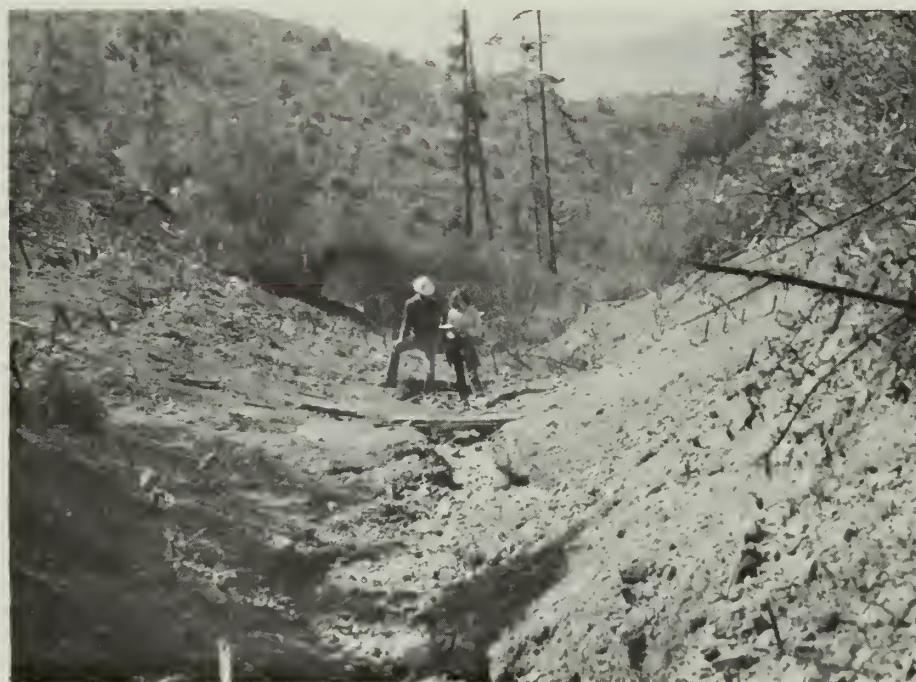
Figure 11: PP7 3/12/79
After photograph of Drainage 6. Newly excavated
channel exhibiting more gentle banks. Note rows
of willow wattle installed on both banks.

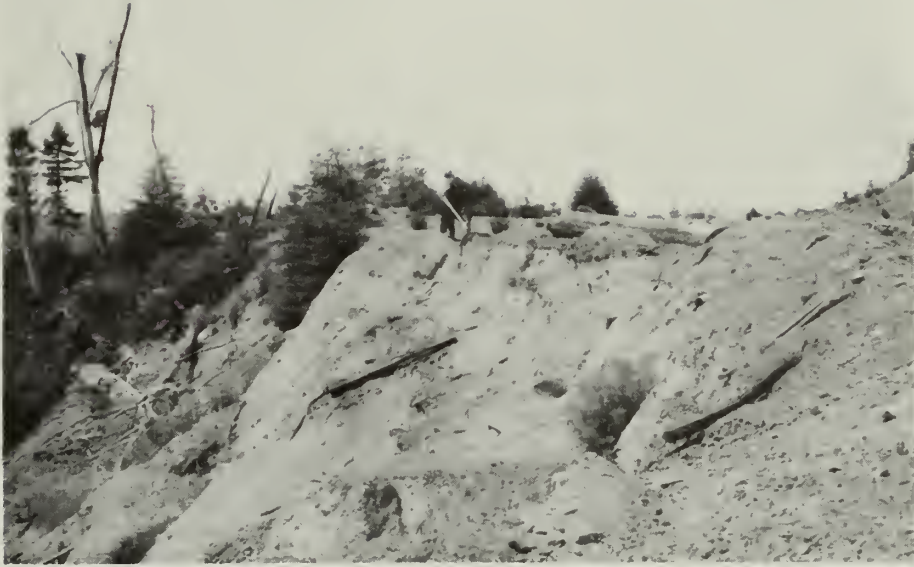
Figure 12: PP3 8/22/78
Before photograph of oversteepened edge of log landing. Some fill material and organic debris have already failed downslope. In addition, water continued to pond on the landing, and tensional cracks suggested future failure of the hillslope.

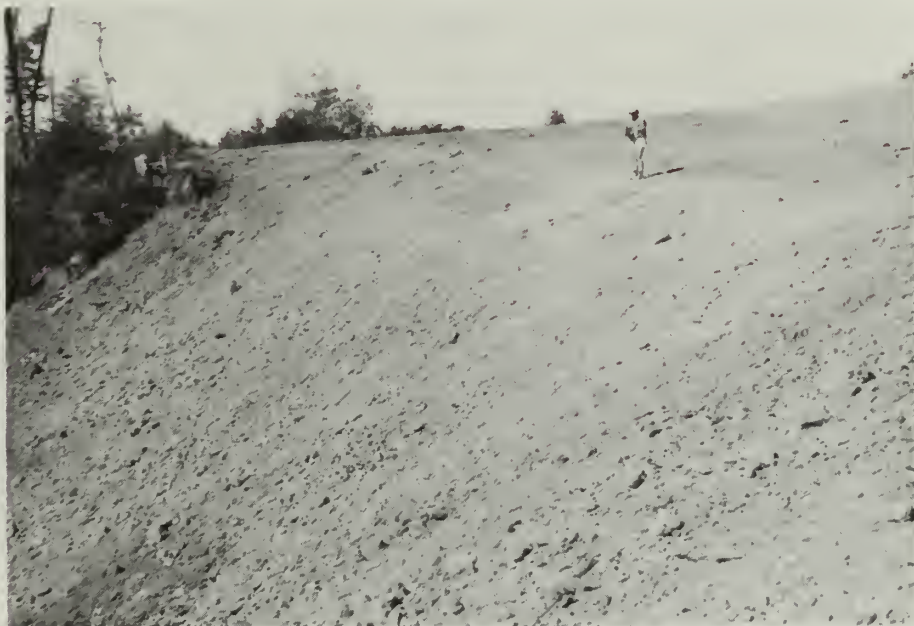
Figure 13: PP3 3/12/79
After photograph of log landing. Edge of landing has been pulled back and fill material was outsloped. Drainage of runoff from the landing has been improved. Willow wattles were planted on the steep slopes below the former landing.

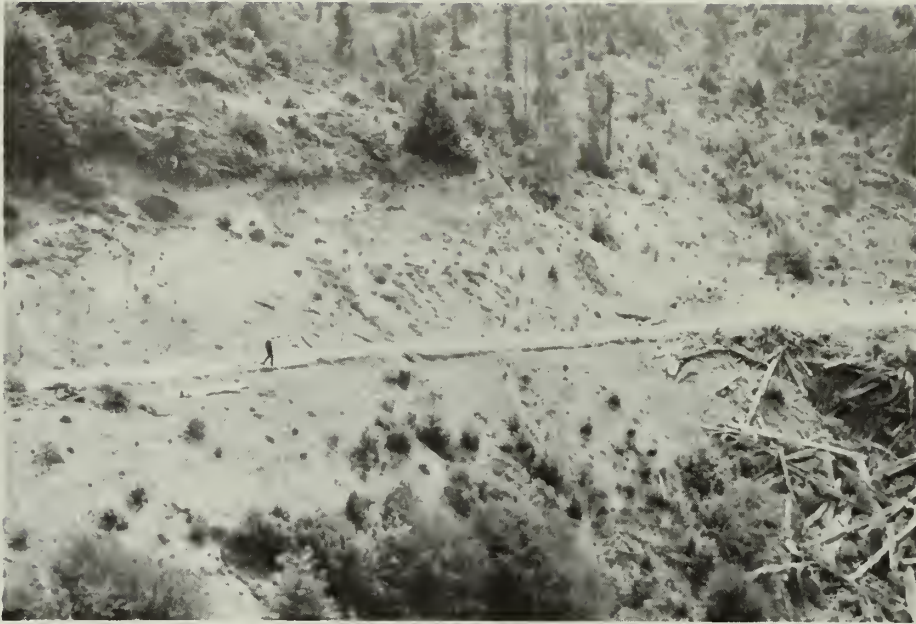
Figure 14: PP5c 8/22/78
 Before photograph of abandoned haul road with unmaintained inboard ditch and steep fill slopes. Landing at right of photo shows perched debris beginning to fail downslope.

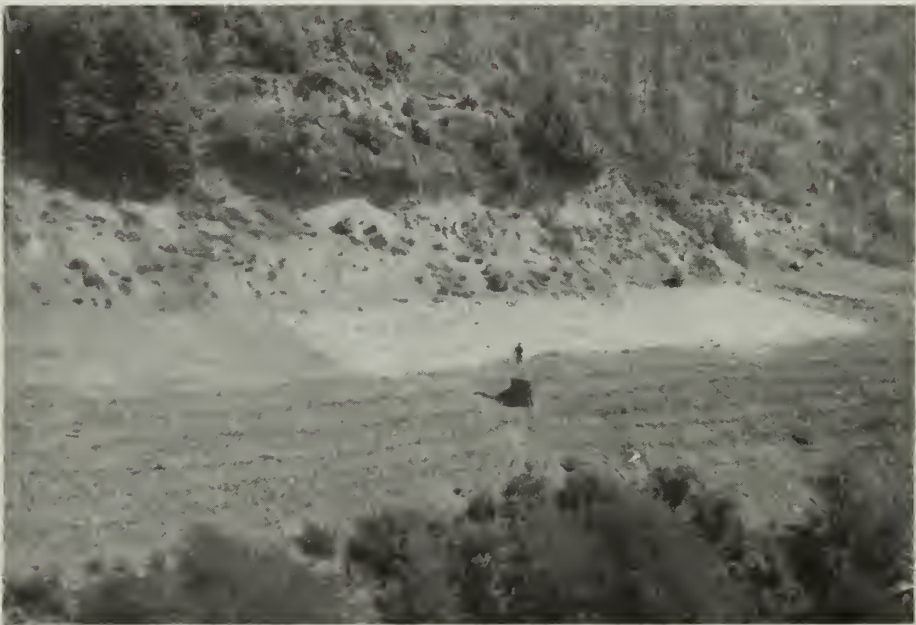
Figure 15: PP5c 10/9/78
 After photograph. Inboard ditch has been eliminated. Steep road fill has been pulled back and outsloped. Perched debris on landing has been removed, and the landing itself has been outsloped to improve drainage. Slopes have been willow wattled and partly mulched with straw.

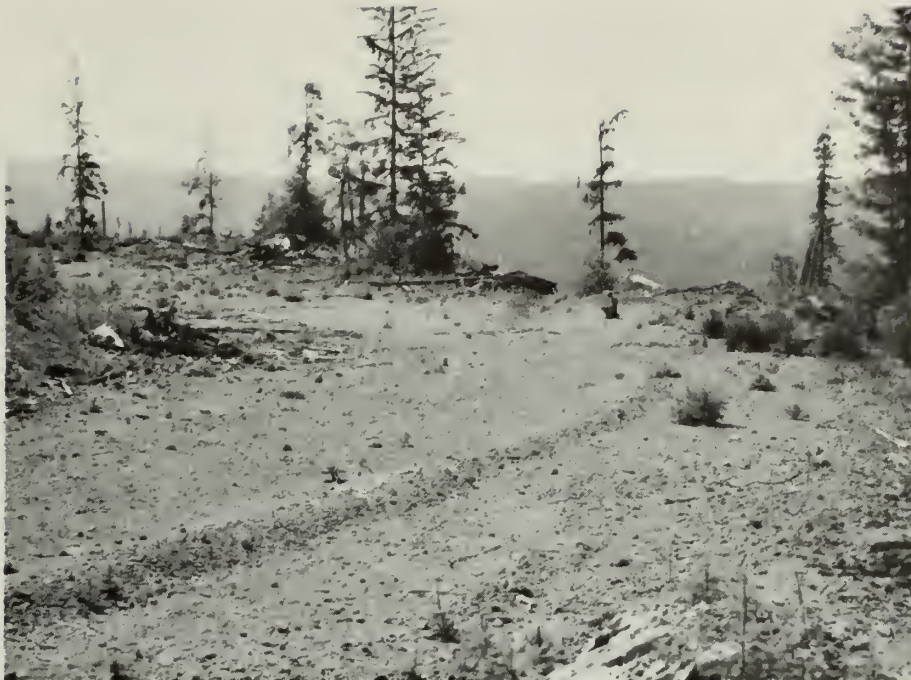
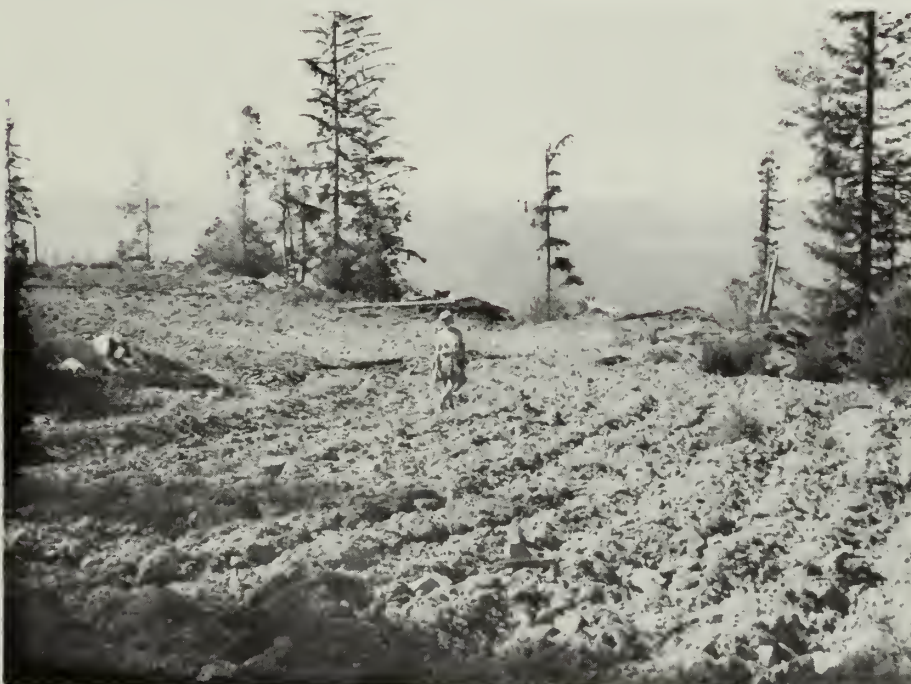
Figure 17: PP22b 10/9/78

Figure 16: PP22b 8/22/78
Before and after sequence of a rocked haul road that was disaggregated (ripped) by a D-8 cat tractor to promote revegetation and infiltration of runoff. Note the paucity of vegetation on the compacted road surface even following 5 to 7 years of non-use.

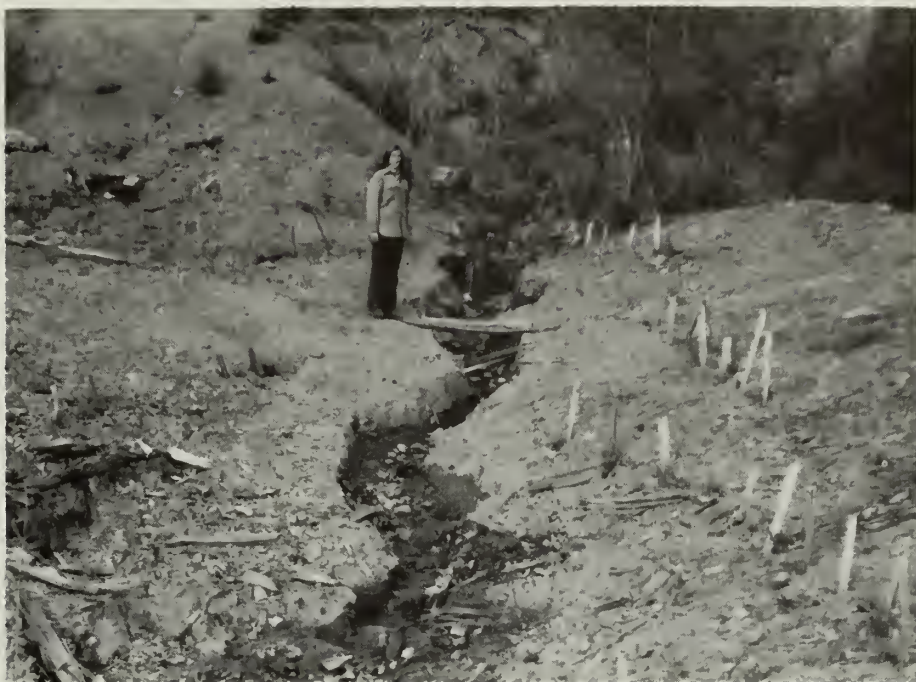
Channels were excavated to the estimated original streambed level. In three cases, excavation was not deep enough and streams downcut 6 to 18 inches during the winter (Figure 18). As the streams downcut, a lag of rocks collected and began to armor the channel bed, inhibiting further downcutting. Channel bed stabilization is important because downcutting undercuts the toes of slopes, resulting in streambank failure. Checkdams were needed to prevent vertical incision in some channels.

Figure 18: Drainage 5 in the Miller Creek Unit. Downcutting occurred in channel that was cleared of debris and road fill. The channel was not protected by an armor of rock prior to downcutting, although a lag of rocks is now beginning to form on the channel bed.

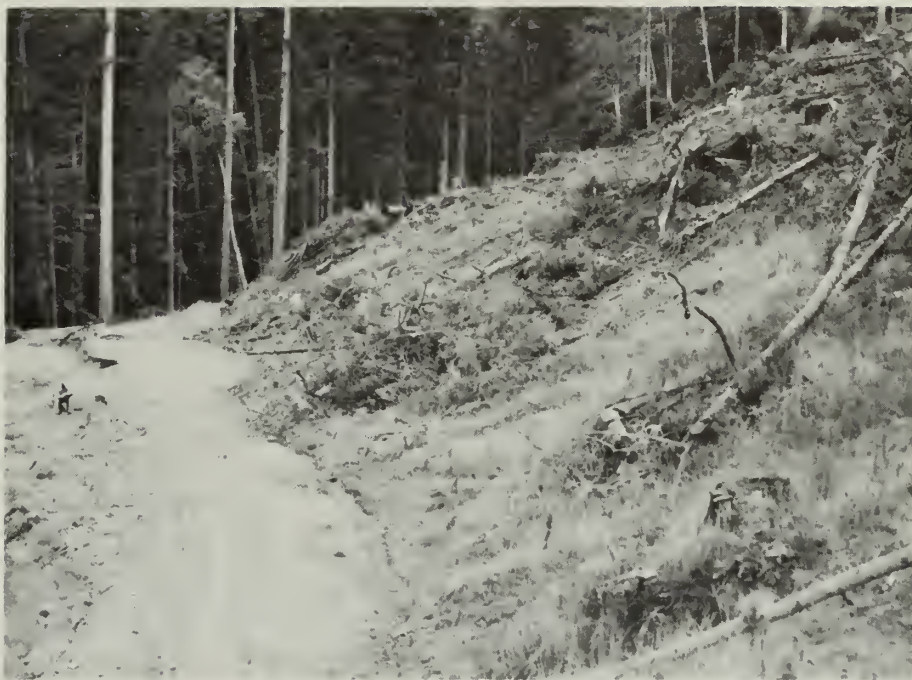
Figure 21: PP16a 8/23/78
C-90 road prior to rehabilitation is showing signs of instability. Small cut bank failures are blocking the inboard ditch. Note the scarp of a road fill failure behind the person at the left of the photo.

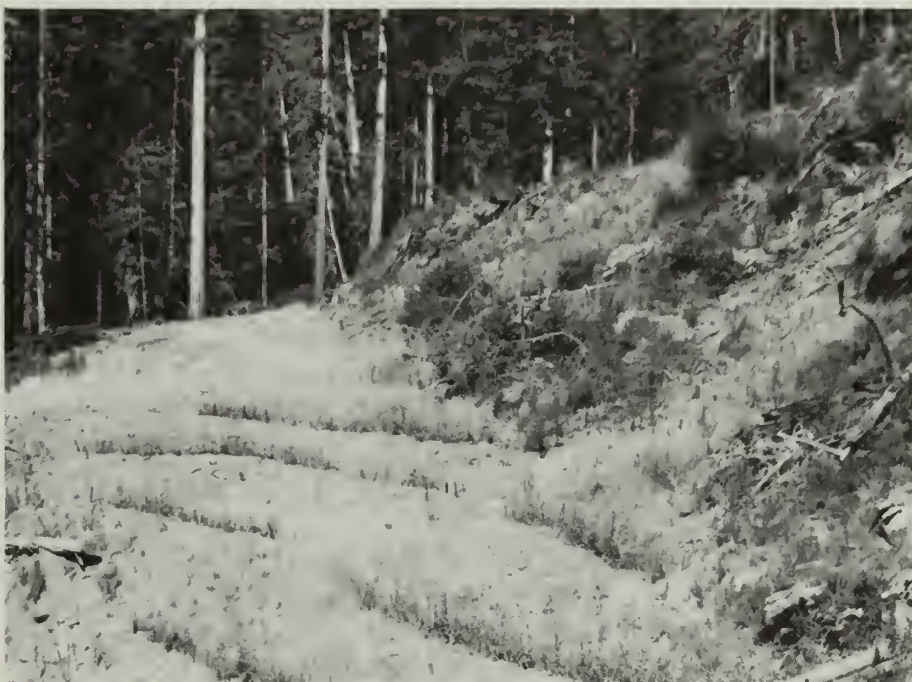
Figure 22: PP16a 10/1/79
C-90 road after rehabilitation. The road has been decompacted, road fill has been pulled back, and the material has been outsloped. Note the rocky cross drain behind the people, and the rows of willow wattles on the outsloped road.

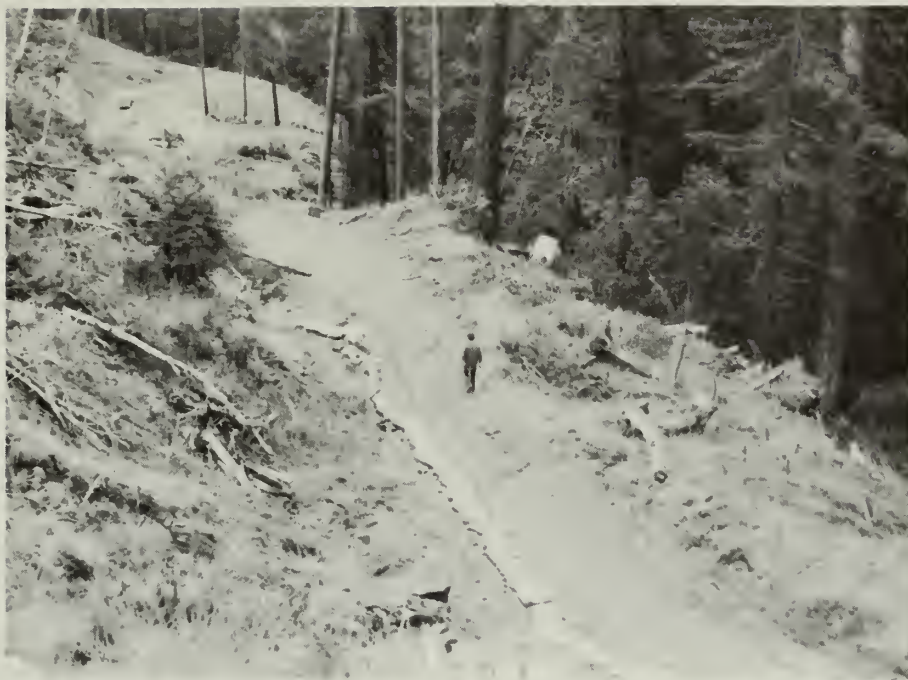
Figure 25: PP16c 8/23/78
C-90 road prior to rehabilitation. Sandbags line the unstable inboard ditch of the rocked haul road.

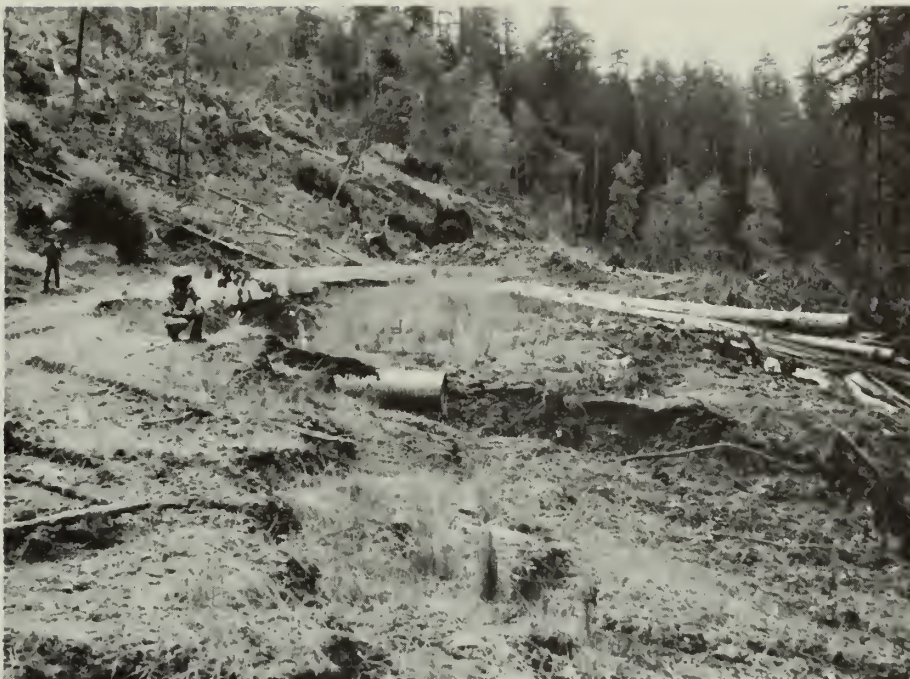
Figure 29: PP14d 8/23/78
Prior to rehabilitation, log landing is truncated by the scarp of a major failure. Culvert is no longer operational.

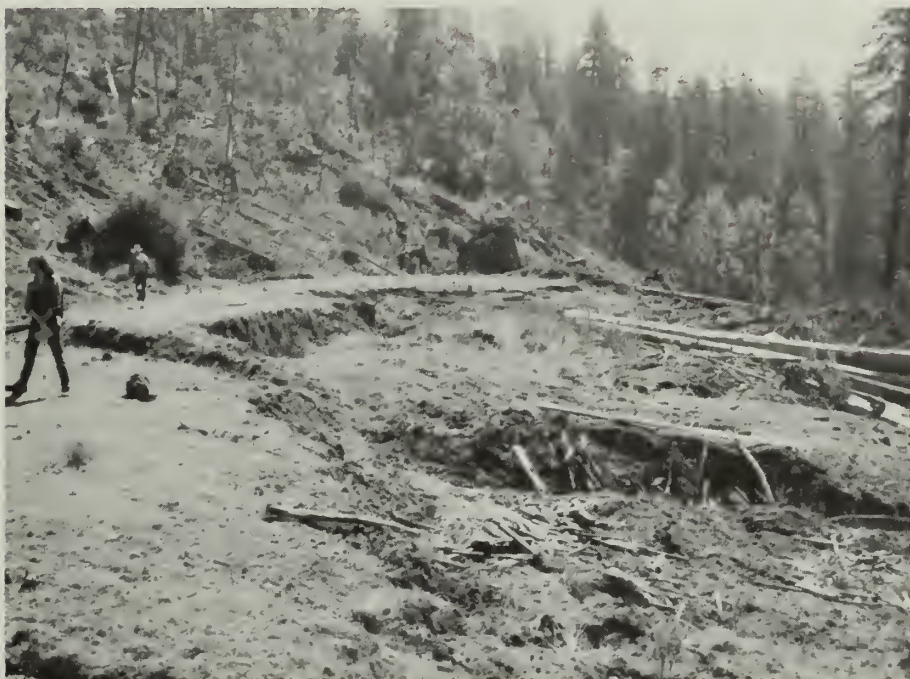
Figure 30: PP14d 3/19/79
After rehabilitation, culvert has been removed and cross road drains have been constructed to drain surface runoff from the site of the failure. In addition, a drainage ditch was dug at the toe of the cut banks to direct runoff into cross road drains. The deep-seated failure was not addressed except through upslope drainage diversions.

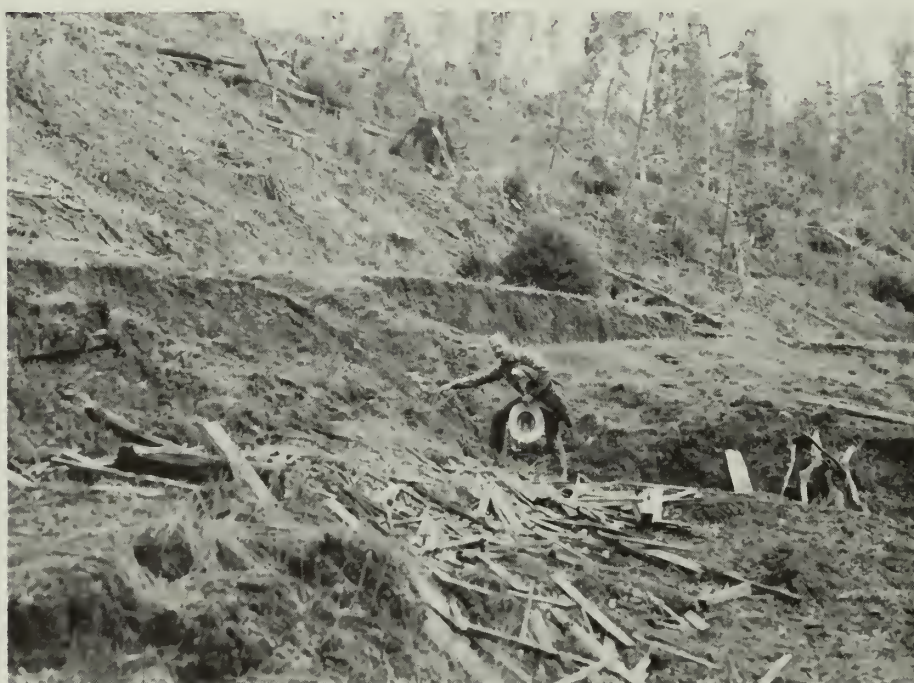
Figure 32: April, 1979.
The outside edge of a landing failed where instability had previously been seen (see Figure 30 for comparison). The man's hand points to a cross road drain that has been truncated by the scarp of this failure.

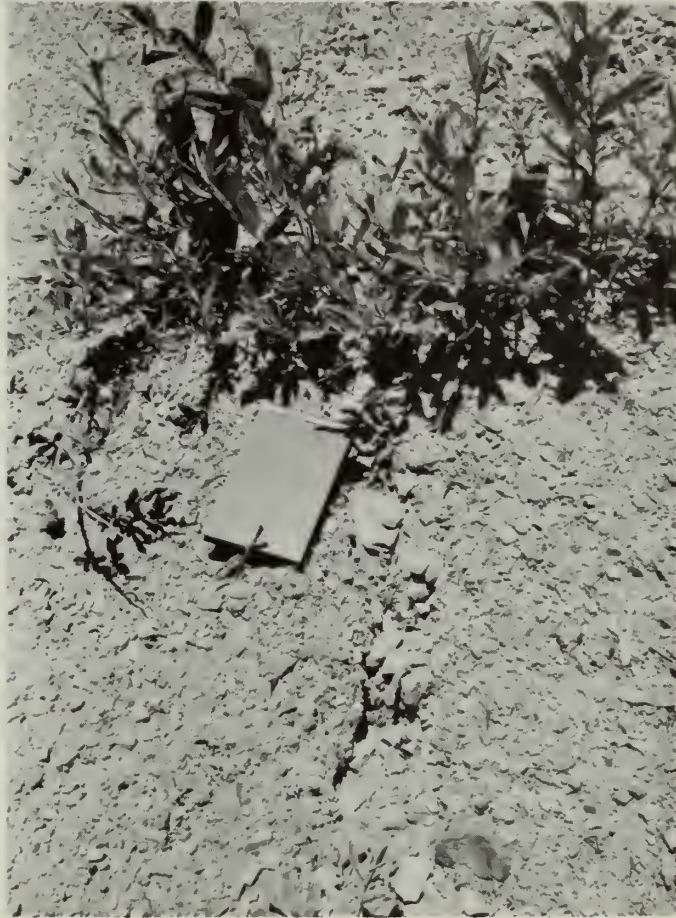
Figure 35: Although willow wattles can disperse small amounts of runoff and impede rilling, they are less effective when subjected to concentrated runoff. Here, a rill beginning upslope of a wattle row carries enough runoff to undercut the wattle and continue rilling downslope.

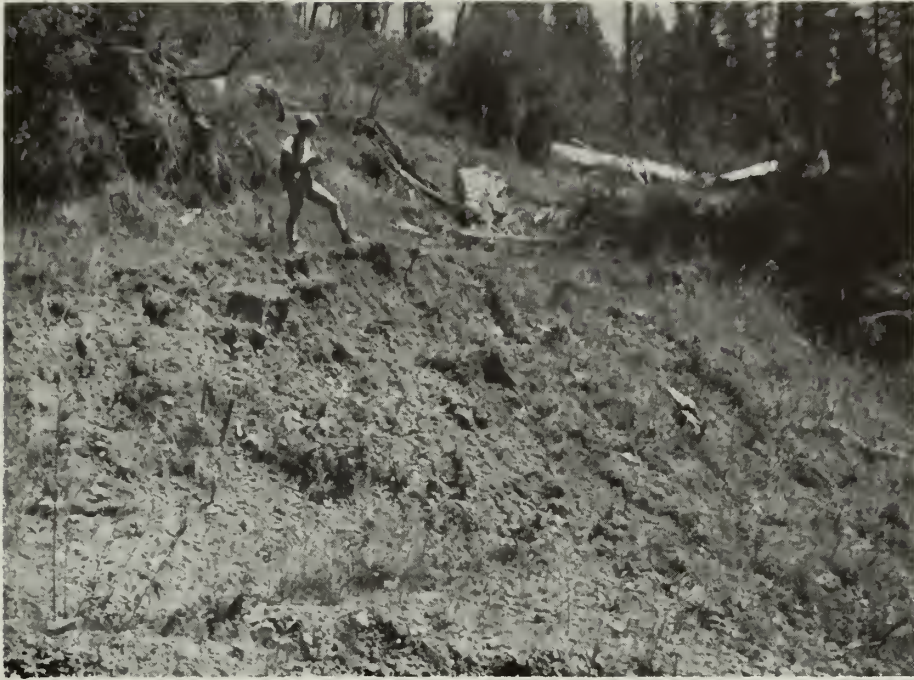
Figure 36: Slump in a cut bank that had been planted with willow stem cuttings a few months earlier. The young sprouts have not yet established an extensive enough root mass to prevent slumping. Note remaining stem cuttings to the left of the center of the photo.

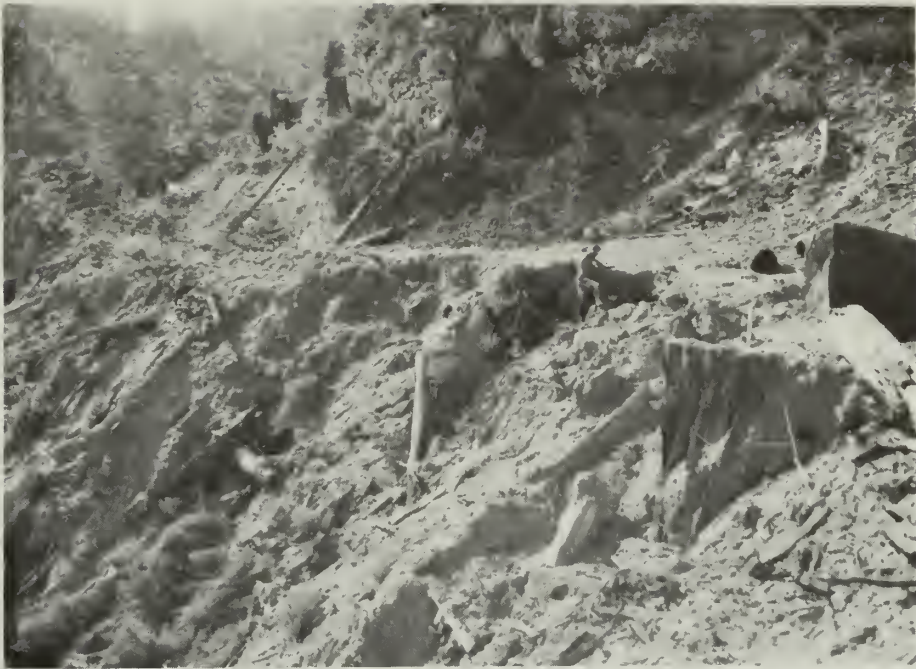
Figure 45: PPA4 9/7/78 Prior to rehabilitation, skid road has unstable, oversteepened fill at outboard edge of road.

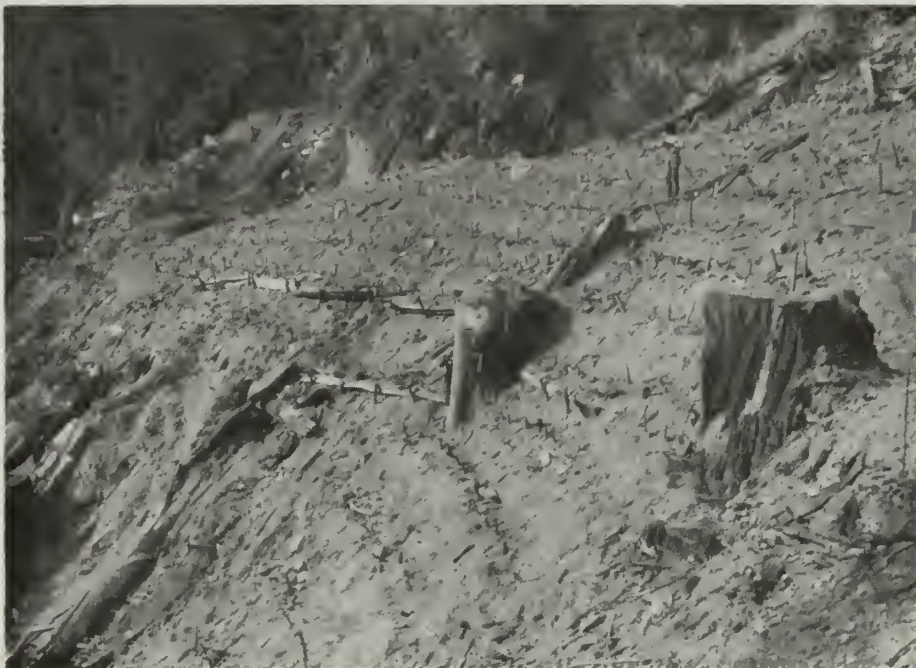
Figure 46: PPA4 1/4/79
After rehabilitation, perched fill has been pulled back by a small backhoe, and road was outsloped. Contour rows of willow wattles were installed just prior to this photo.

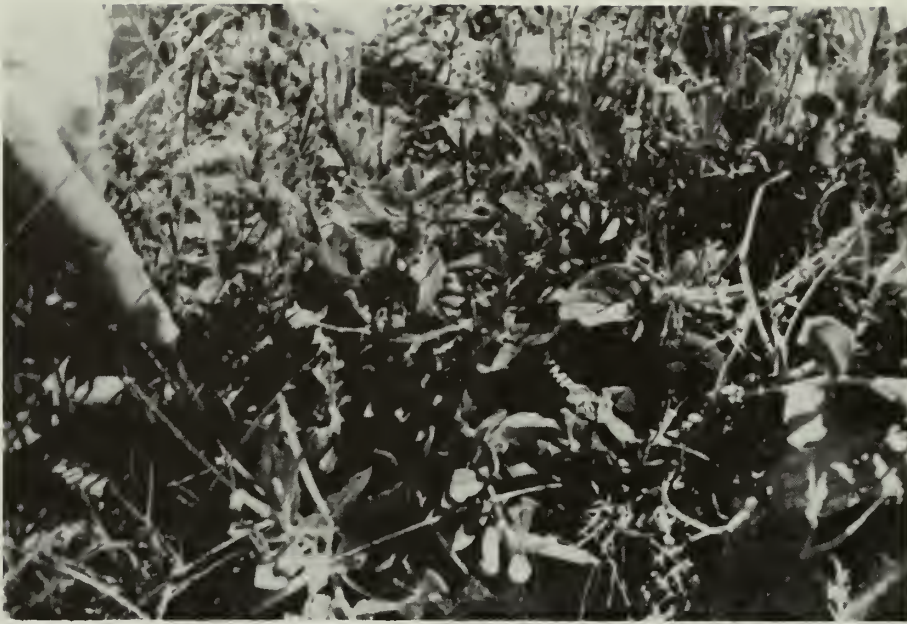
Figure 51: Roosevelt elk and black-tailed deer browse on young willow sprouts. Nipped-off ends of sprouts are evident on this willow bundle, but generally little damage has occurred due to animal presence on the rehabilitation sites.

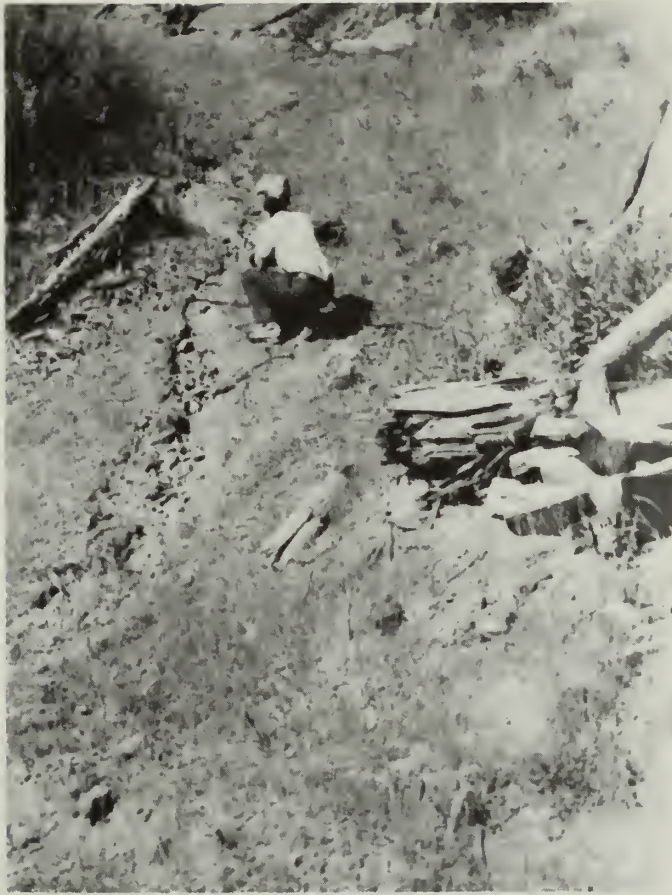
Figure 53: A rill has developed on a skid road which was seeded with grasses. Under high runoff conditions and where runoff is concentrated on roads, a grass cover does not prevent rilling. Ground cover is approximately 50%.

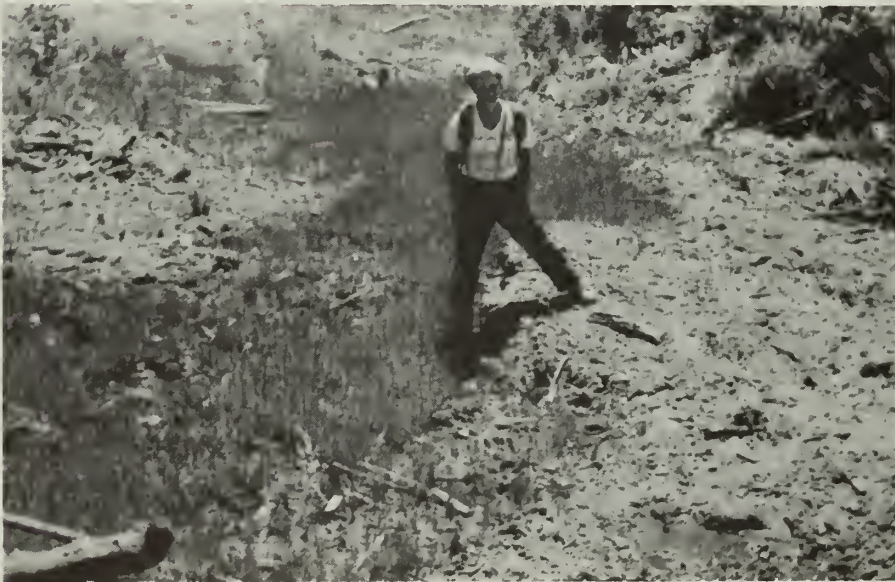
Figure 55: Grass seed and fertilizer were applied at equal rates on all areas of this skid road. The moist site on the left side of the photo has a fairly good grass cover developed; survival of grass is much poorer on the drier site on the right-hand side.

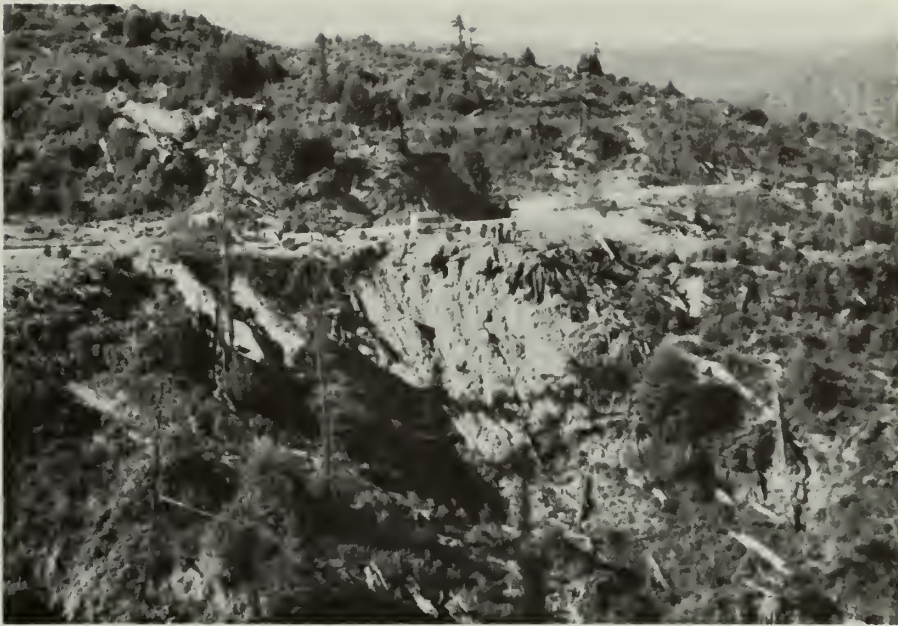
Figure 56: PP3 10/2/78
View towards C-Line landing prior to any rehabilitation work. Part of the landing failed, leaving much of the organic and inorganic debris perched precariously.

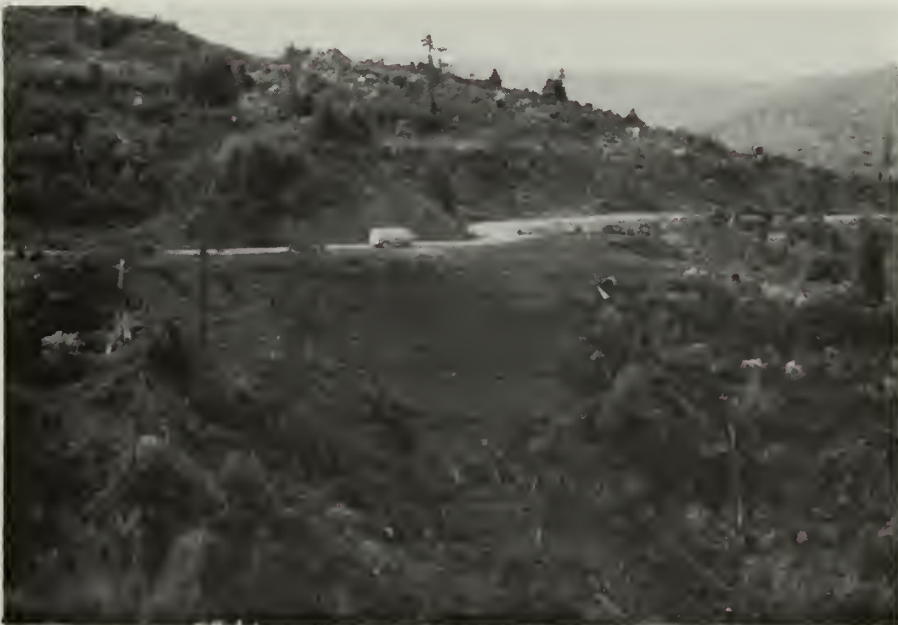
Figure 57: PP3 12/20/78
A dragline crane pulled back the unstable fill and debris, and a cat tractor moved it to stable skid roads. Wattle rows of willows and other species were planted on the slopes.

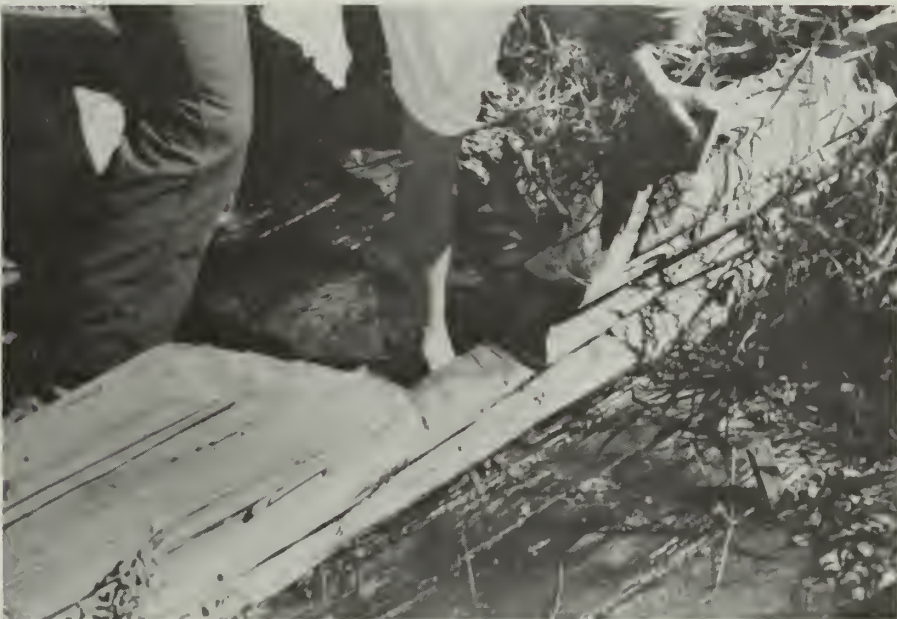
Figure 67: June, 1979
 Leakage between splashboard energy dissipator and base of check dam. Ponding effect of the check dam is lost and consequently little sediment is deposited in the catch basin upstream of the dam.
